IV. The Capitol in Use

VI. The Grand Project

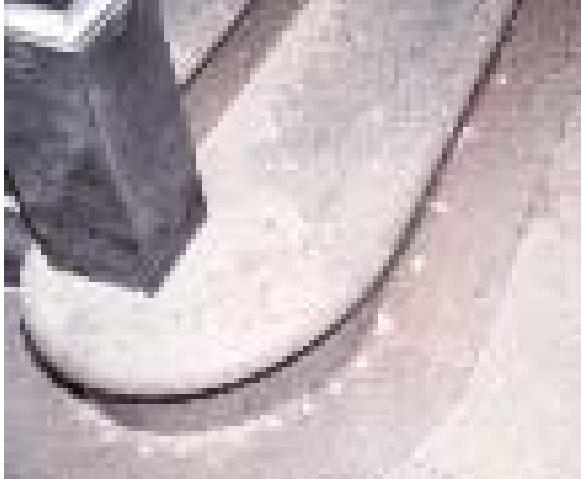
Damage caused by driving carpet nails directly into a marble floor. (Kathleen Sitter, LRB)

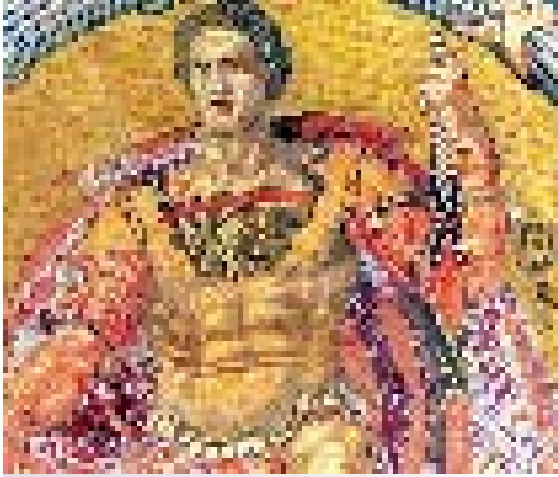
Portions of Kenyon Cox's mosaics were repaired with an inferior adhesive, marring their appearance. (Kathleen Sitter, LRB)

destructive. The supreme court murals by Albert Herter were particularly badly damaged by poorly chosen restoration methods. These murals were extensively painted over by restorers misinterpreting the original intent of the artist. The murals in the Governor's Conference Room by Hugo Ballin were also damaged by overpainting and cleaning. Portions of Kenyon Cox's rotunda mosaics were reglued using a cement that, on close inspection, looked nothing

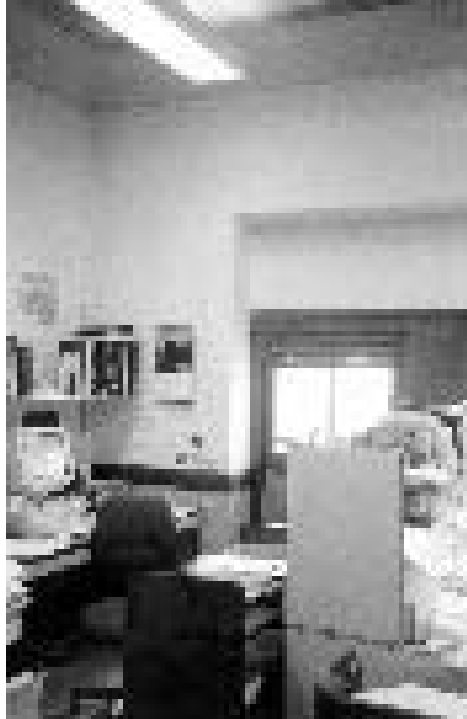
Cramped quarters and florescent lighting were the norm in the capitol by the 1980s. (East Wing Architects LLC)

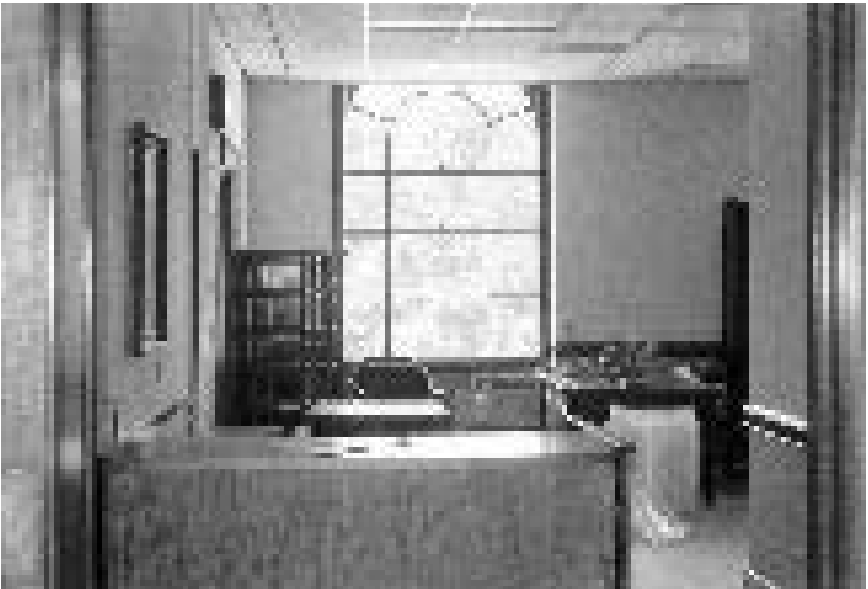
Acoustical ceilings were installed in many areas of the capitol without regard to the architectural integrity of the building. (East Wing Architects LLC)

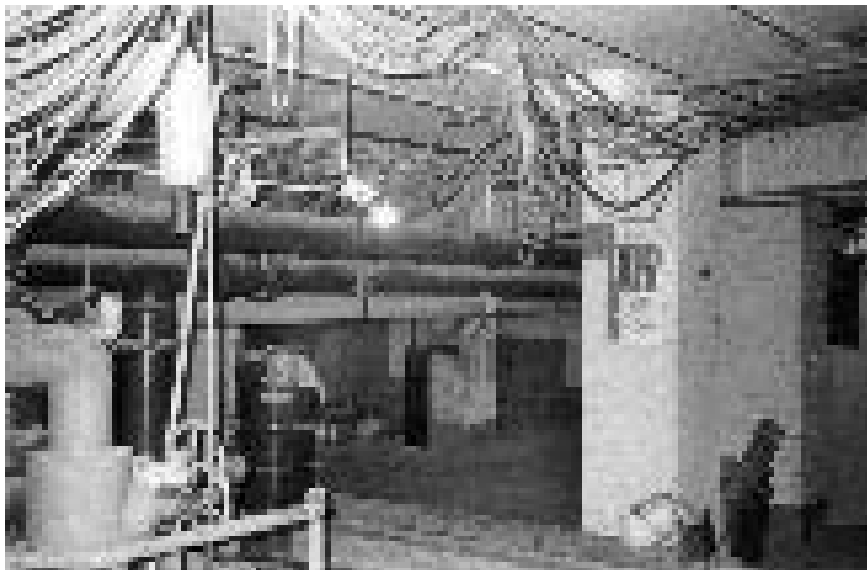
By the 1980s, the capitol's basement had become a choked maze of pipes and wires (above). The basement floor was lowered several feet, and conduit and ductwork laid beneath (below). (Department of Administration, Division of Facilities Development)

the grid was laid, the concrete floors were repoured. In keeping with the Master Plan, electrical outlets were added unobtrusively in the rotunda and in the nearby passageways.

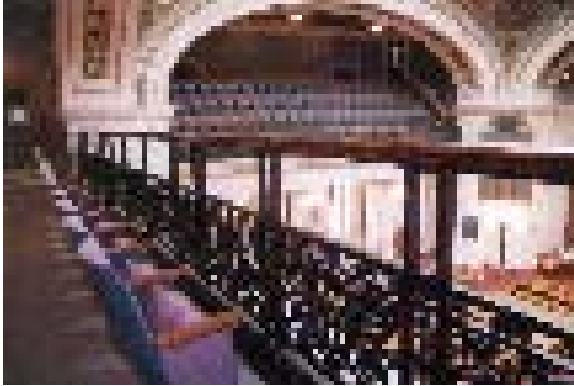
Safety and aesthetics were served by modifications to the railing in the assembly gallery. (Kathleen Sitter, LRB)

much too short to ensure the safety of spectators and eventually were in violation of safety codes. Sometime along the way, a glaringly utilitarian upper rail had been added along the top of the original. During the renovation, architects designed a higher ornamental railing more in keeping with the design of the original railing and of the same metal content.

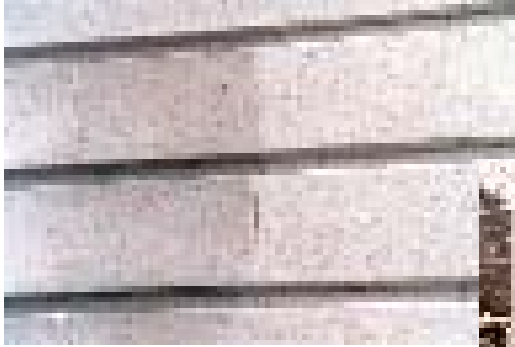
Exterior granite before and after sponge-jetting. (Kathleen Sitter, LRB)

White Bethel granite. It removed the grime without taking off any of the stone itself or damaging it. Every inch of the exterior had to be treated directly by sponge-jetting, which required the construction of scaffolding around the exterior of the capitol. This work was done in 2000 and 2001 independently of the interior work. The resulting restoration of the exterior walls to their original whiteness was particularly dramatic while the process was still underway and untreated gray portions of the walls remained for comparison.

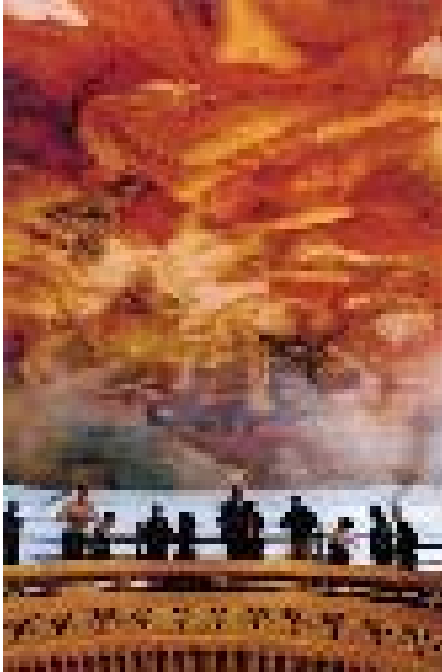
Edwin Blashfield's mural in the dome oculus was in better shape but still required some attention. The most noticeable problem was grime and graffiti along the edges of the mural; this was a remnant of the period early in the capitol's history when tourists were allowed to go unsupervised to the top of the interior dome. The mural was cleaned and retouched, with particular attention to the areas that had been damaged by tourists.)

Edwin Blashfield's oculus mural had been damaged by tourists who were permitted unsupervised access to the dome during the capitol's early years. (Richard G.B. Hanson II)
