WETLAND DELINEATION REPORT

**Veterans Park Campground
Sec 17, T 35 North, R 13 East**

Prepared for:
Mr. Travis Wollenberg
County Forest Administrator
Forest County
200 East Madison Street
Crandon, WI 54520

Prepared by:
Molly Gardner
Coleman Engineering Company
200 East Ayer Street
Ironwood, Michigan 49938
906.932.5048

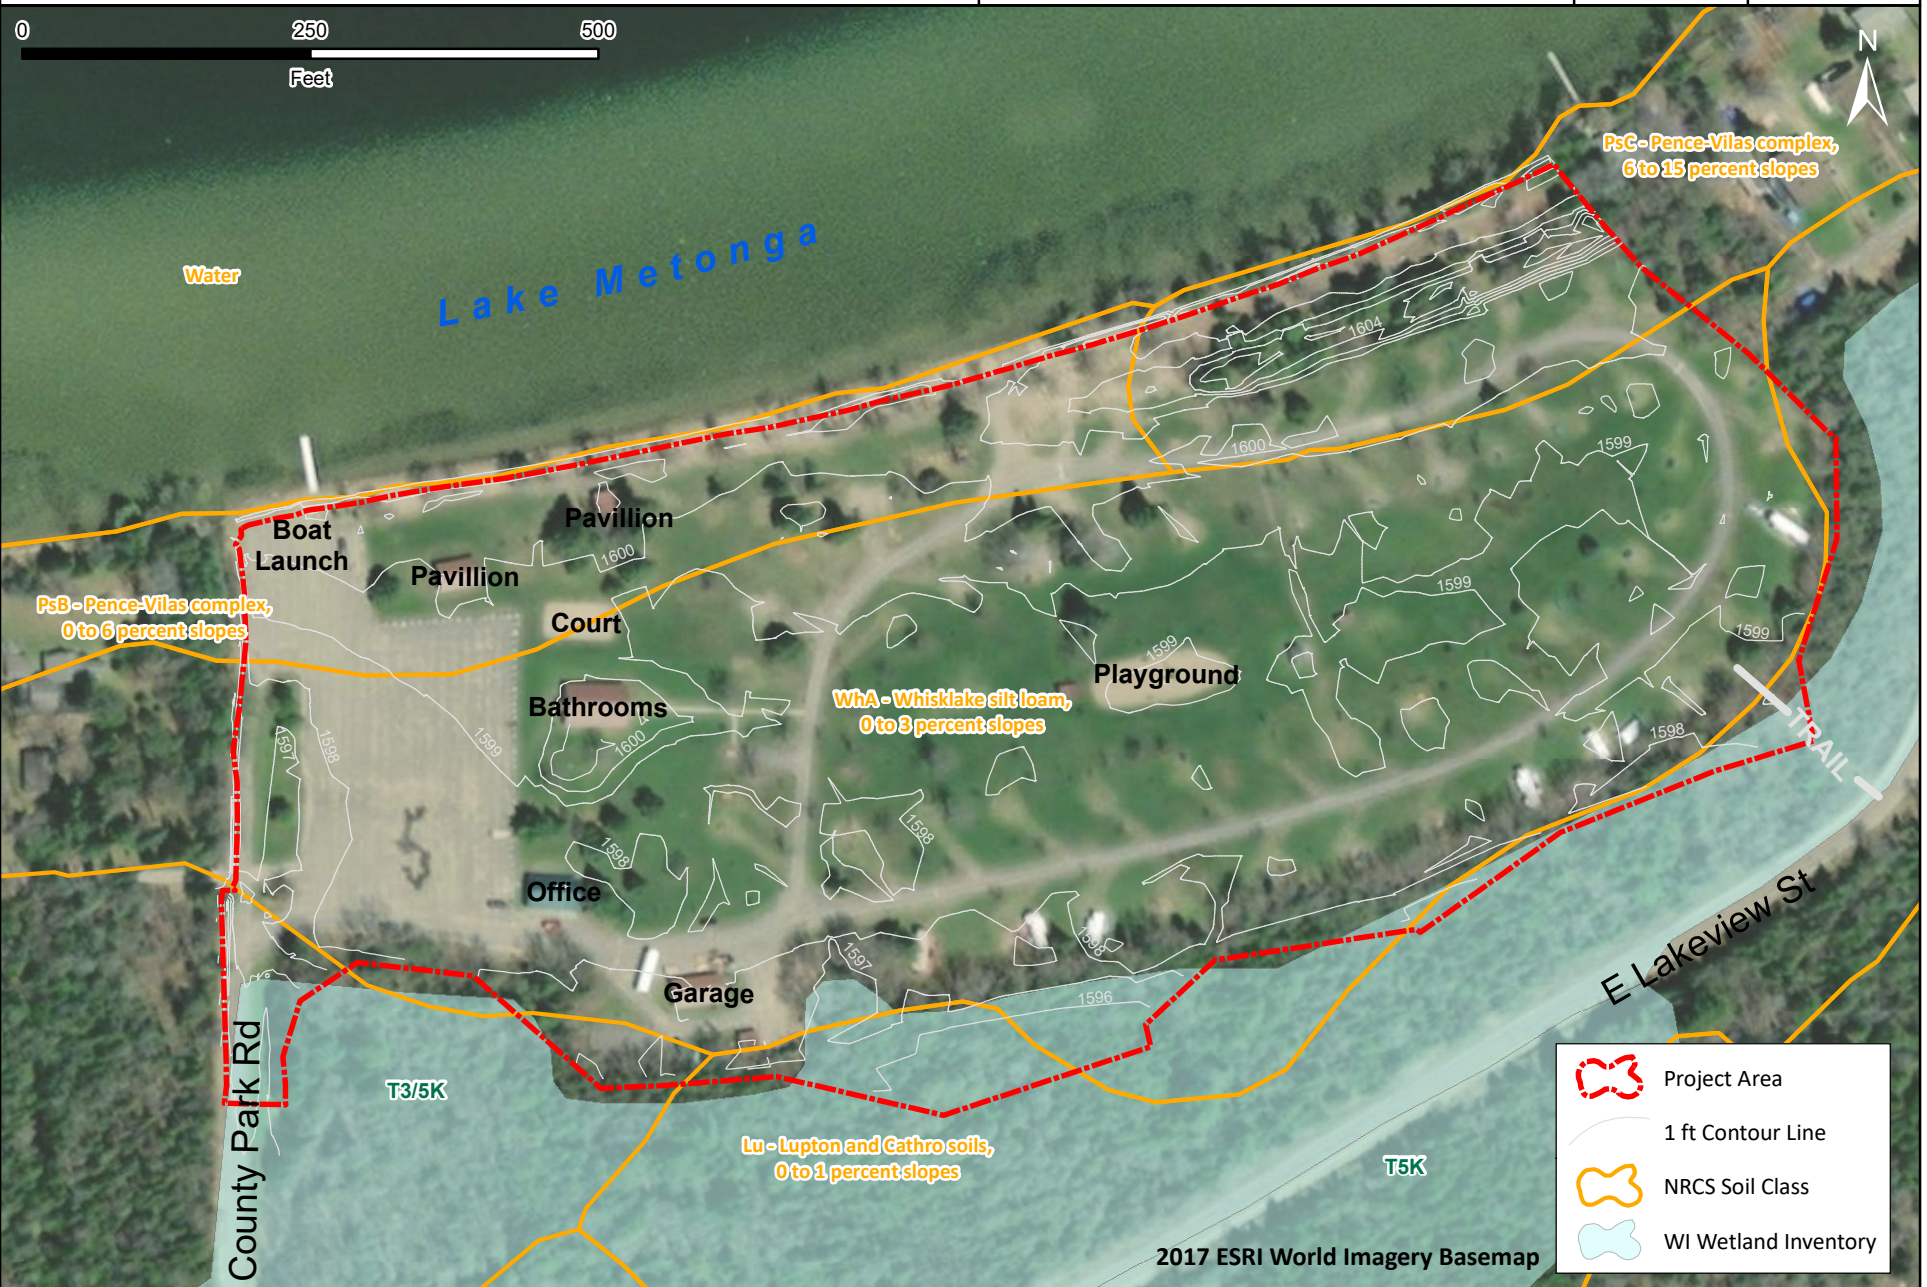
Figure No:
Fig 2
Drawn By:
MCG

Feature Map

The WWI descriptions of the wetland types found in the Project Area are classified consistent with the Cowardin Classification of Wetlands and Deepwater Habitats of the United States, 1979. Figure 2 in Appendix A shows a large, WWI mapped, mixed forest wetland across the entire southern boundary of the Project Area and continuing south to and across East Lakeview Street.

The NRCS database classifies and defines soil associations nationwide based upon geology, landform, relief, climate, and natural vegetation of the area. Figure 2 in Appendix A displays the main four soil complexes within the Project Area.

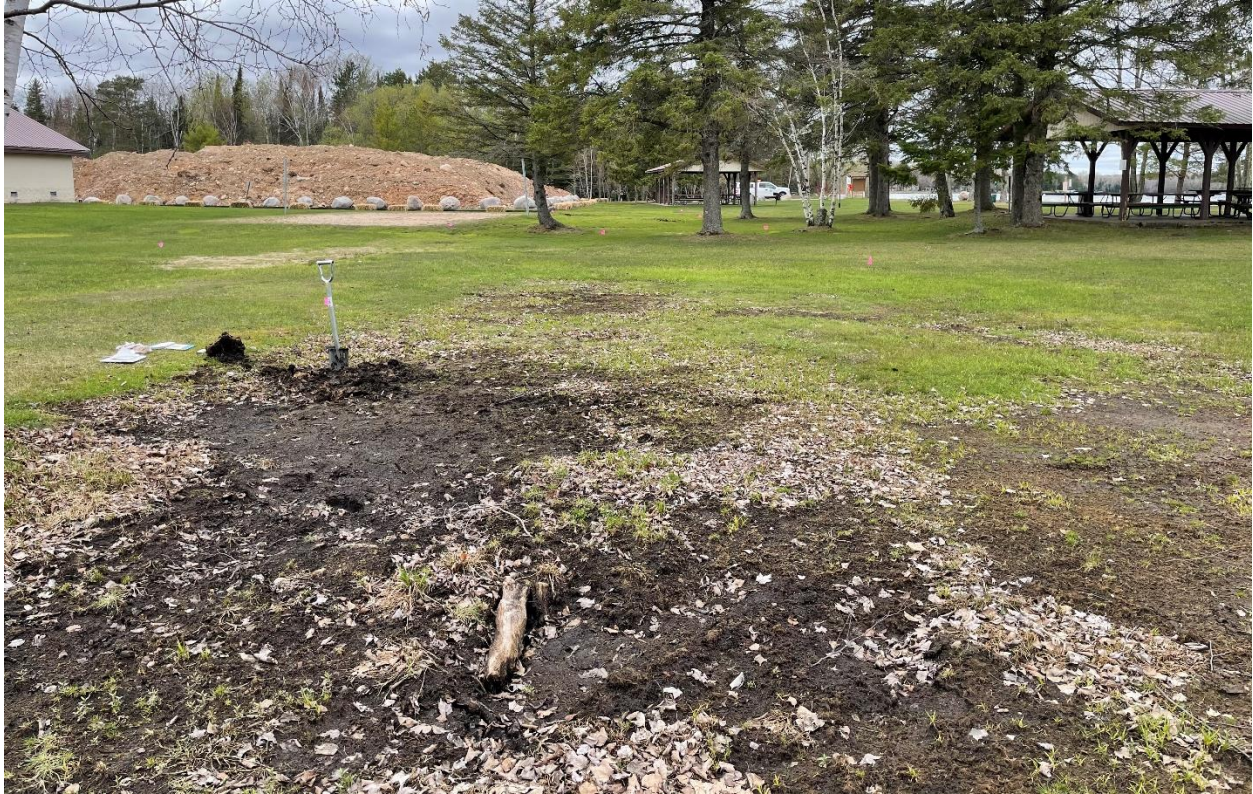
Photo 1 – Wetland A from eastern end facing west

The Project Area contained two wetlands. Wetland A is pocket wetland in a slight depression located in the northwest quadrant of the Project Area and is located on the Wetland Map in Appendix A. Wetland A was determined to be a persistent, emergent wetland classified by the Wetlands and Deepwater Habitats Classification system as PEM1. It was first identified by a slightly wet signature on aerial imagery and wetland soil on nearby boring log B-3 that met the hydric indicator S3. The vegetation in Wetland A has been categorized as significantly disturbed since its alteration to maintained lawn. The soils examined in Wetland A were comprised of a sandy topsoil underlain by mucky peat. Data Sheets detailing this information are located in Appendix C.

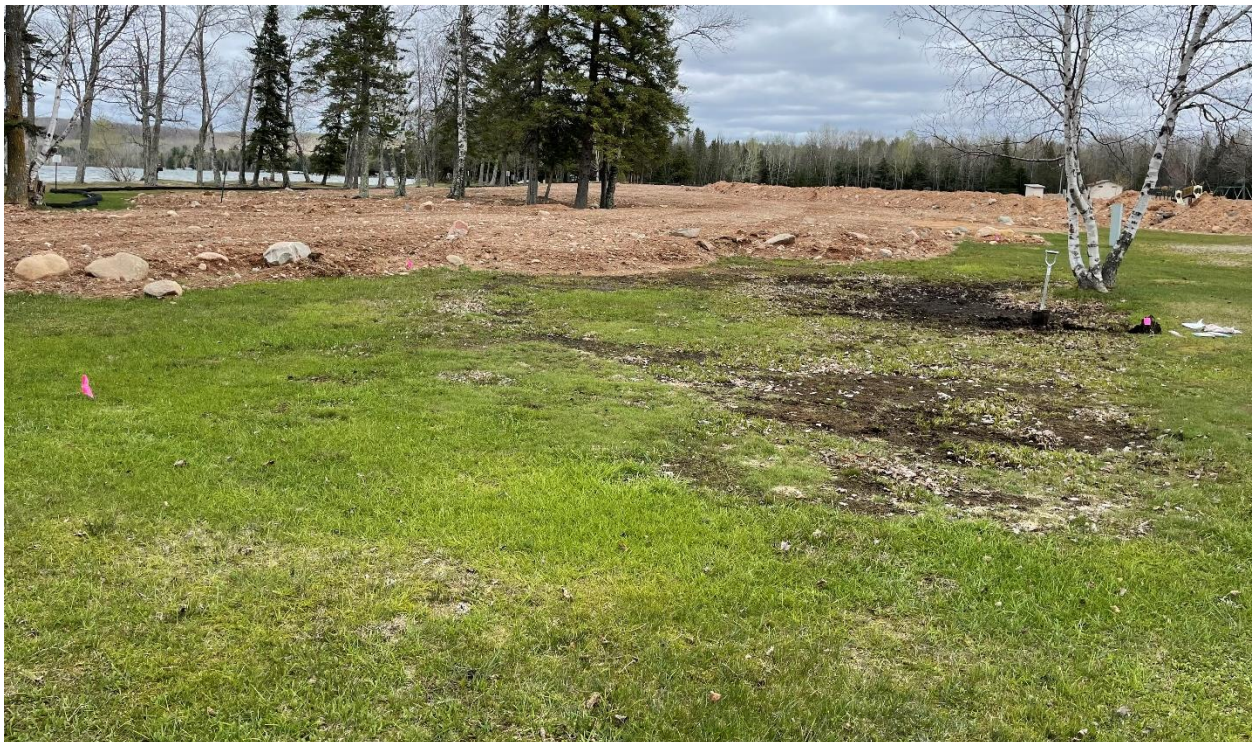
Photo 2 – Wetland A from center facing east

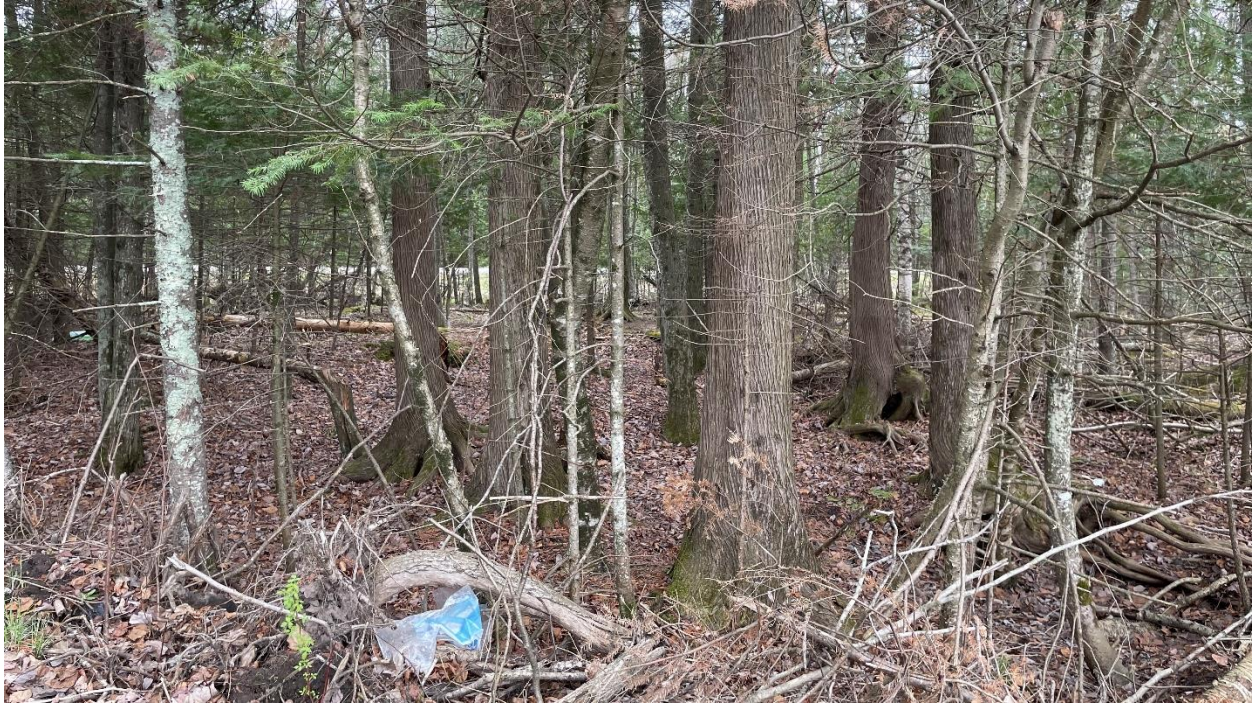
Photo 3 – Wetland B from northern boundary facing south - east end of project area
Note: E Lakeview St in background

Wetland B is a larger wetland complex located across the southern boundary and along the eastern chain link fence just east of the Project Area. Wetland B is a hummocky northern white cedar and balsam fir dominated wetland. The topography continues to gradually grade downward off site to the south to East Lakeview Street. The soils in Wetland B were observed to be unaltered by historic construction activities. They were very wet and comprised of muck which is typical of the Lupton and Cathro soil series. The culverts in the southwest quadrant of the Project Area aid in concentrating the runoff from the parking lot on the western portion of the site to the southwest of the Project Area.

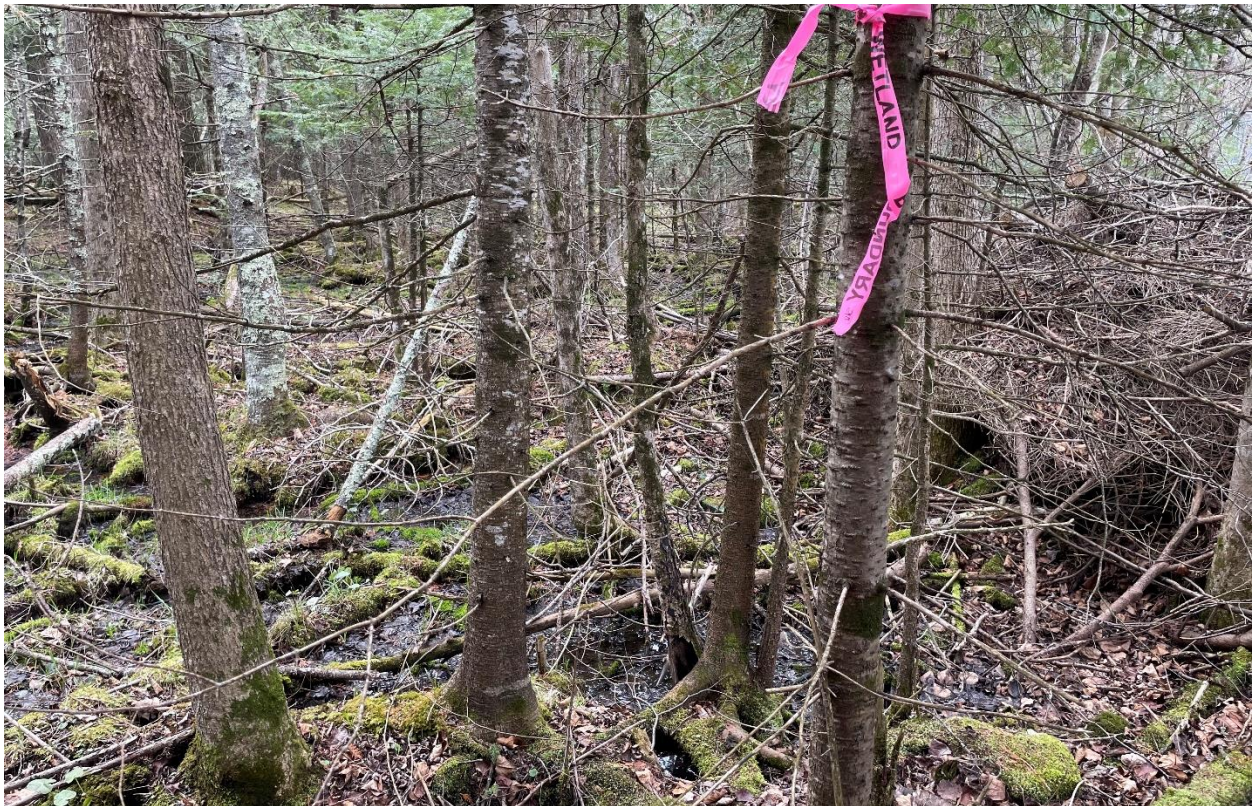
Photo 4 – Wetland B from northern boundary facing south – western side of project area

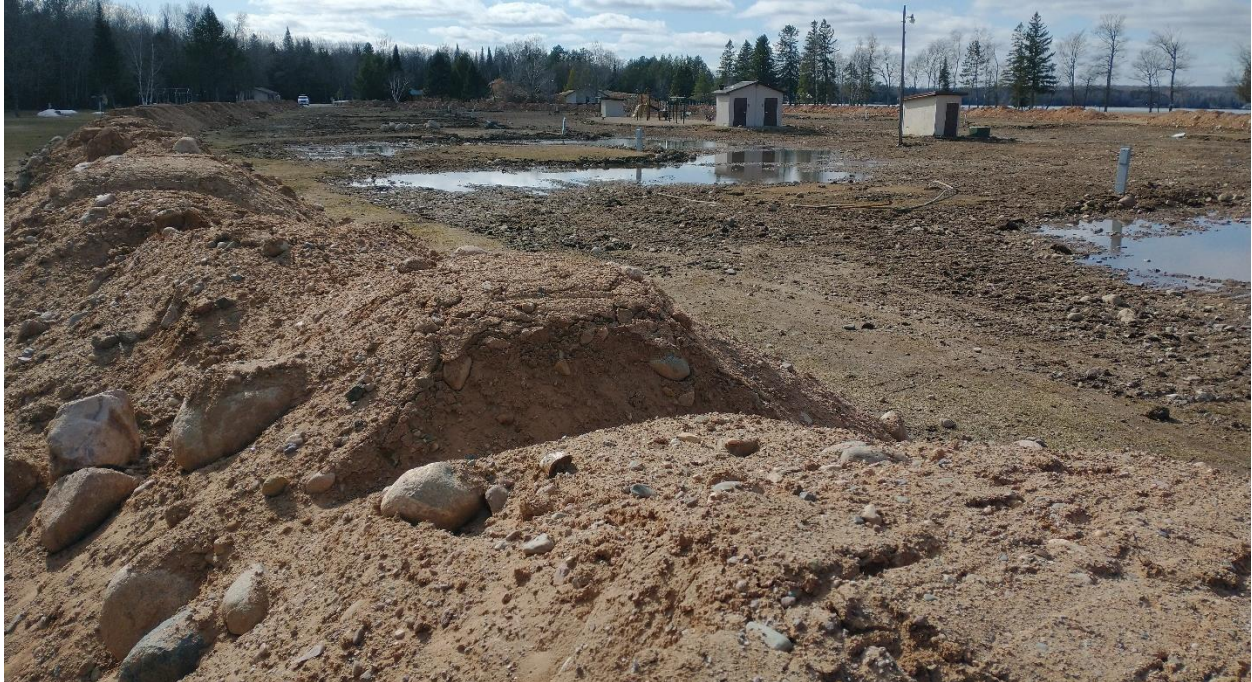
Photo 5 – Topsoil scraped central campsites and road (under fill material)
from southeast of Project Area facing northwest

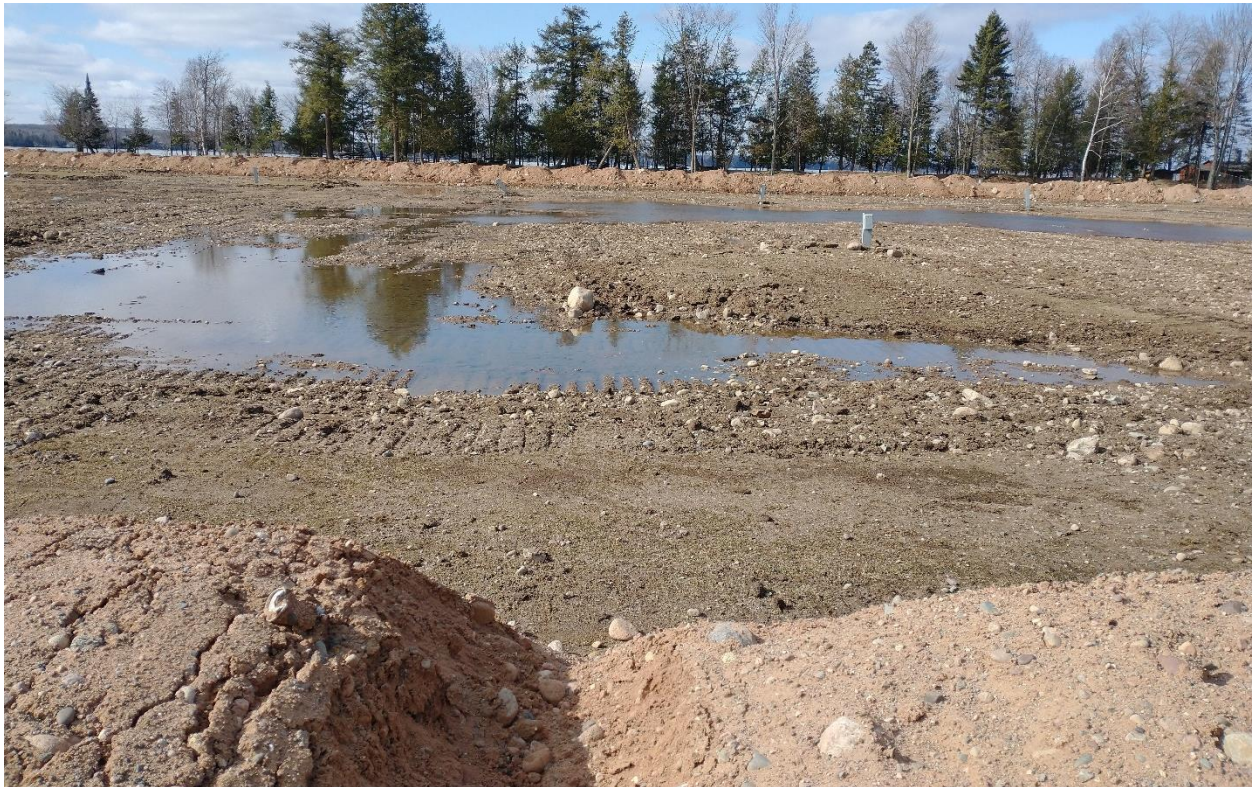
Photo 6 – Topsoil scraped east central campsites and road (under fill material)
from southeast of Project Area facing north
